A Robotic Vision System for Rapid Inspection and Evaluation of Solar Plant Infrastructure

Final Project Report incorporating results and
lessons learnt

ANU College of
Engineering &
Computer Science

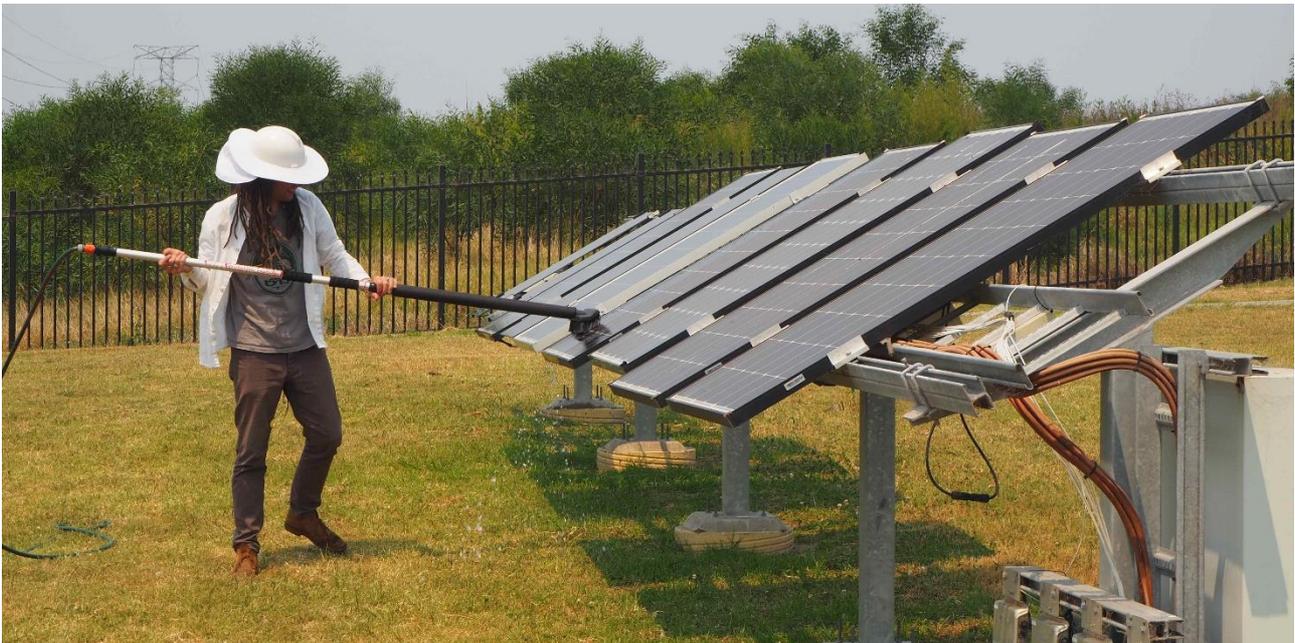
Fig. 1: Hand cleaning of a PV installation at CSIRO Energy in Newcastle, Australia, as part of before and after power measurements to calibrate the effect of soiling on PV power generation.

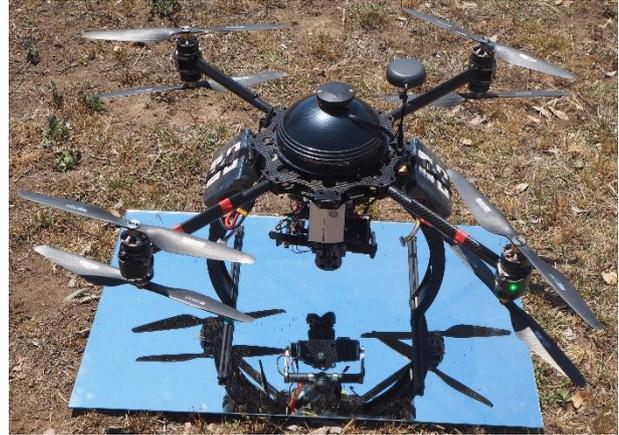
Fig. 2: The aerial drone used pictured on a mirror during testing of RTK positioning capability.

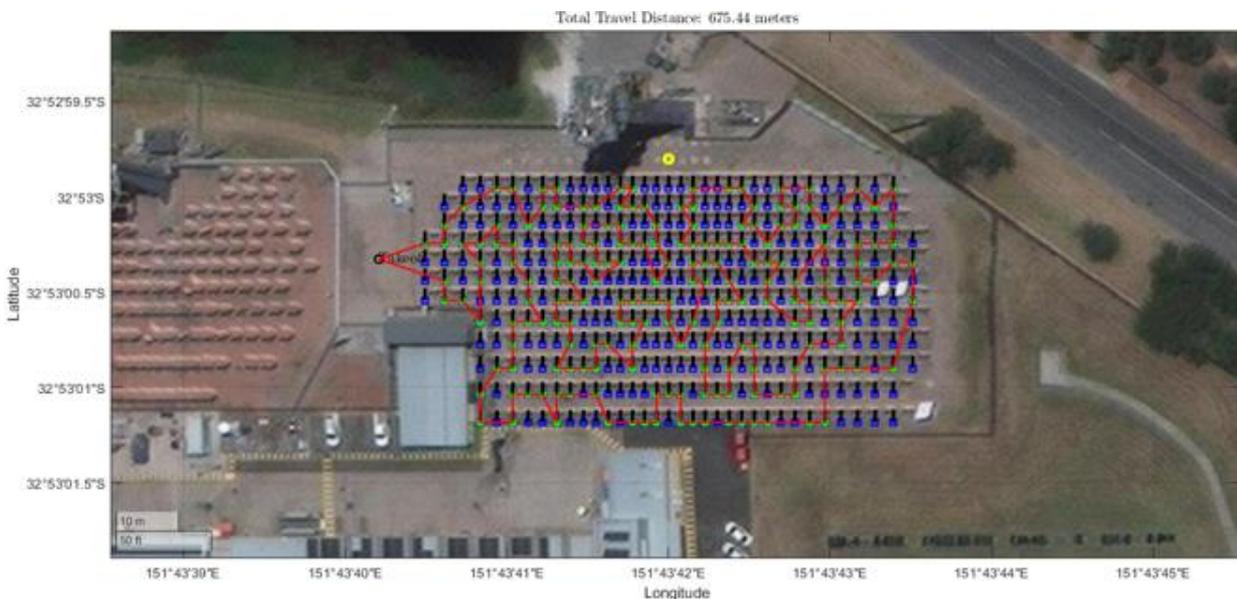
Figure 3: A typical path generated by solving the travelling salesman algorithm for an example CSP plant. Each green point is a way point generated stochastically to provide confidence of overall spatio-temporal soiling levels without requiring imaging of every heliostat. The red path is the planned trajectory, optimised for time of flight and guaranteed to return the vehicle to base within the mission duration window. The final mission planning software developed is a collection of subroutines that generate feasible mission plans for inspection flights and interfaces into the open source autopilot software ArduPilot.

For a typical commercial solar field, with +10,000 modules, only a subset of the possible panels can be targeted in a given flight and a stochastic algorithm to sample panels was developed to provide statistical confidence in the data collected. A waypoint for each panel targeted is generated based on the survey information available from the field considered. The drone autopilot servo controls to each waypoint, at 3m above the desired panel, and at an angle of 10degrees from vertical to avoid imaging the sun or imaging the drone. A time-optimal trajectory amongst the panels was generated by using the Travelling Salesman Optimisation (TSO) problem.

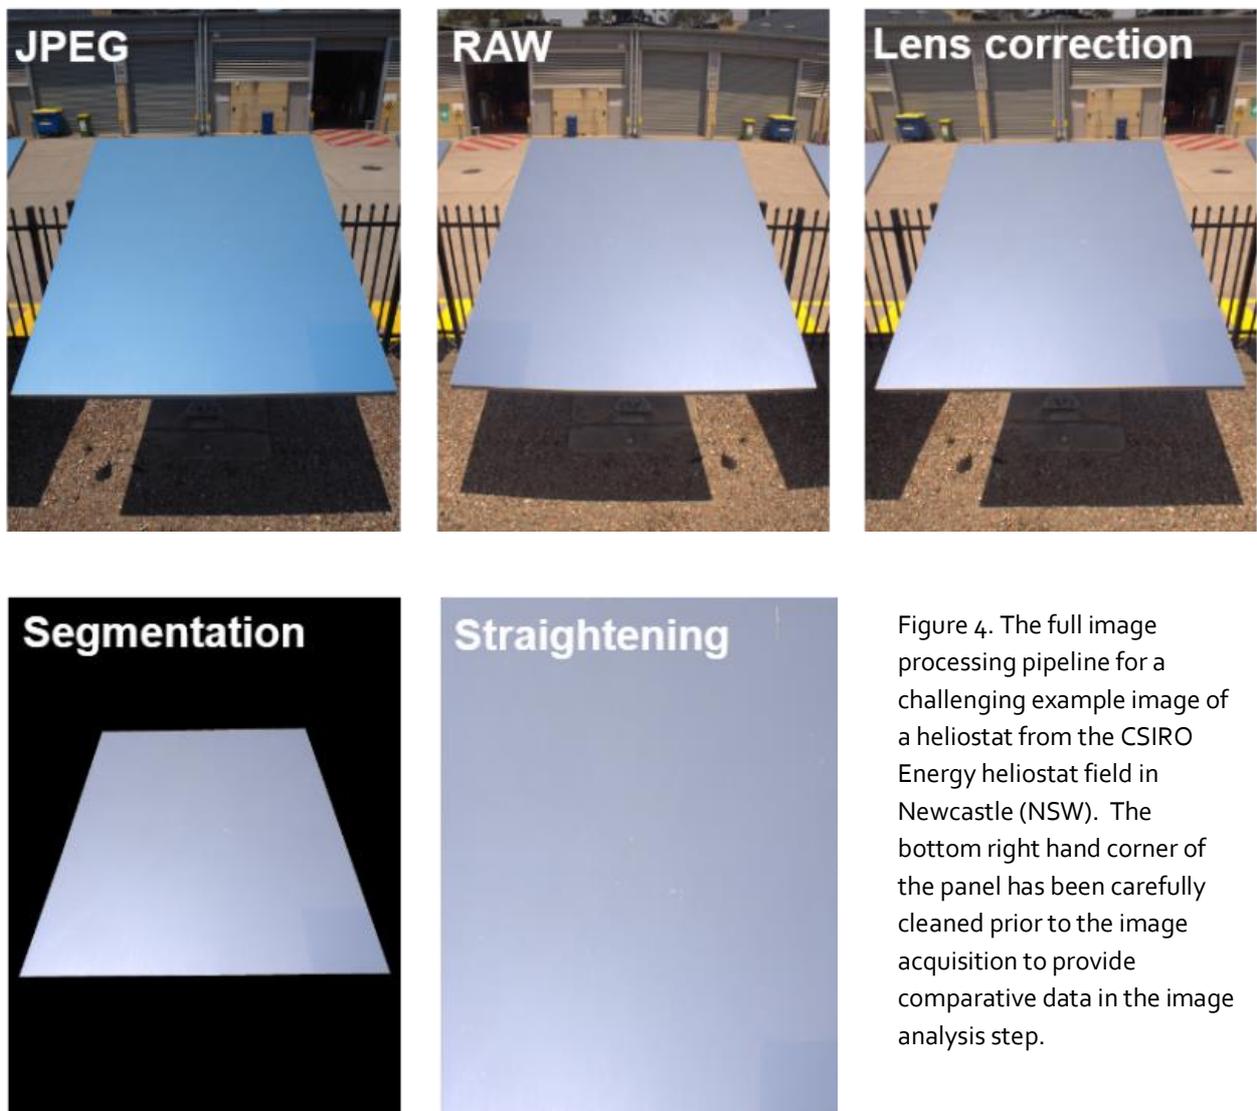
Figure 4. The full image processing pipeline for a challenging example image of a heliostat from the CSIRO Energy heliostat field in Newcastle (NSW). The bottom right hand corner of the panel has been carefully cleaned prior to the image acquisition to provide comparative data in the image analysis step.

The image processing software is a collection of software routines that reads from a directory of images acquired during an inspection mission. Each image contains a perspective view of a target panel as referenced by the mission plan log. Each image is processed to correct for camera colour characteristics and lens corrections. Then the heliostat or PV panel is segmented from the general image and a straightening operation is undertaken that

transforms the resulting image to a fronto-parallel image of the panel, as though the drone was directly in the normal direction of the panel/heliostat when the image was taken. In this way, images from different flights can be compared and directly overlaid to identify temporal changes. Moreover, the image analysis algorithms can be tuned for a single set of geometric parameters.

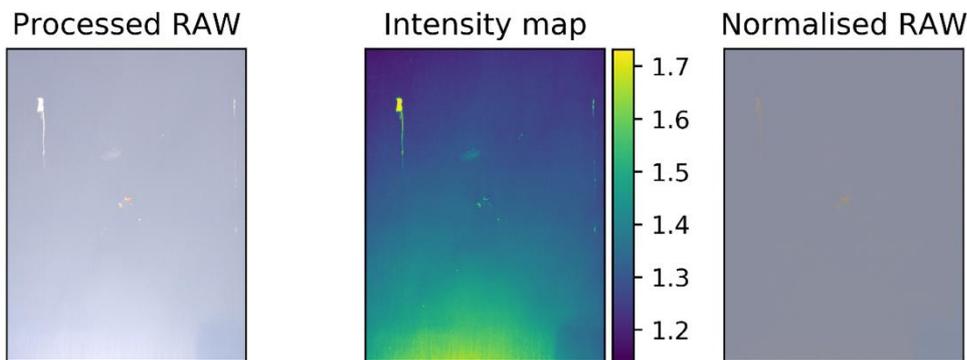
Figure 5. The sky model normalisation for panel N32 in the CSIRO Energy Heliostat Field 2 in Newcastle (NSW).

The image analysis module of the software processes the fronto-parallel images from the previous module to extract information on soiling and defects. The first stage identifies a sky model for each image. In Figure 5 the output from the image processing is shown in image a). The actual intensity of the image is visualised using a colour mapping in image b). There is clearly a localised soiling of the mirror (bird scat) in the top left of the mirror and a visible clean patch in the bottom right (each panel was had a small square area cleaned to provide comparative data). There is also a clear high intensity region in the lower central section of the image that is due to the changing light intensity of the sky imaged by the mirror. The sky variation is modelled and removed to generate a normalised image as shown in image c).

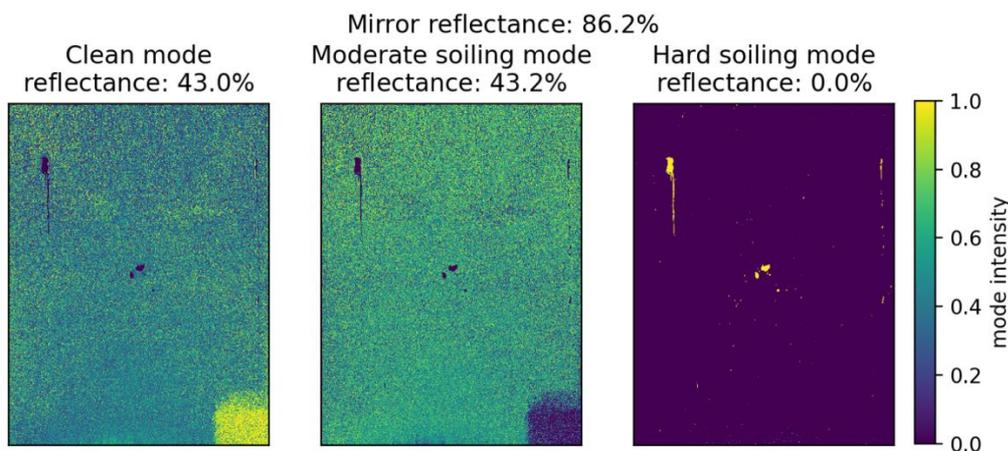
Figure 6. The reflectance classification for module N32 of the CSIRO Energy Heliostat Field 2 in Newcastle (NSW)

The normalised image is fitted to a 3 mode spectral classification associated with clean sky reflection, moderate soiling (associated with dust), and hard soiling (bird scat and mirror damage). The relative intensities of the criteria are shown in Figure 4. The hard reflectance classification clearly identifies the bird scat soiling on the mirror. The ratio of clean reflectance classification to moderate soiling reflectance can be correlated to provide a good estimate (within 1% accuracy) of the actual mirror reflectance as measured with a reflectometer. For this mirror the level of soiling was high, yielding an overall reflectance of 86.2%. The reflectance in the cleaned patch in the bottom right of the mirror is clearly differentiated from the remainder of the mirror and had a reflectance of 94%.

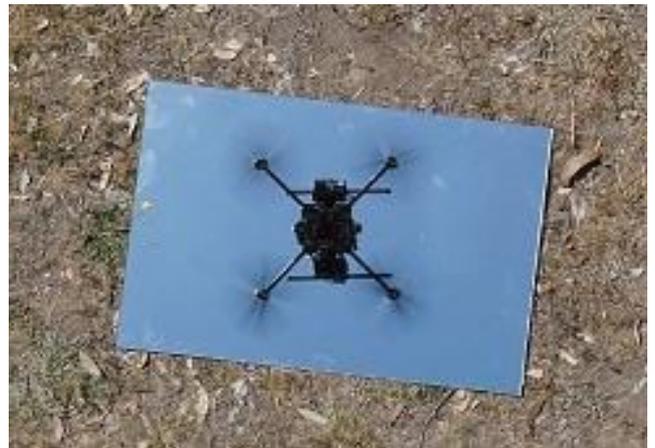
Fig. 7: An image taken during RTK testing. The way point was set directly over the test mirror and the camera oriented to image the drone. In real data collection, the drone would be offset and the camera would image the sky in the mirror.

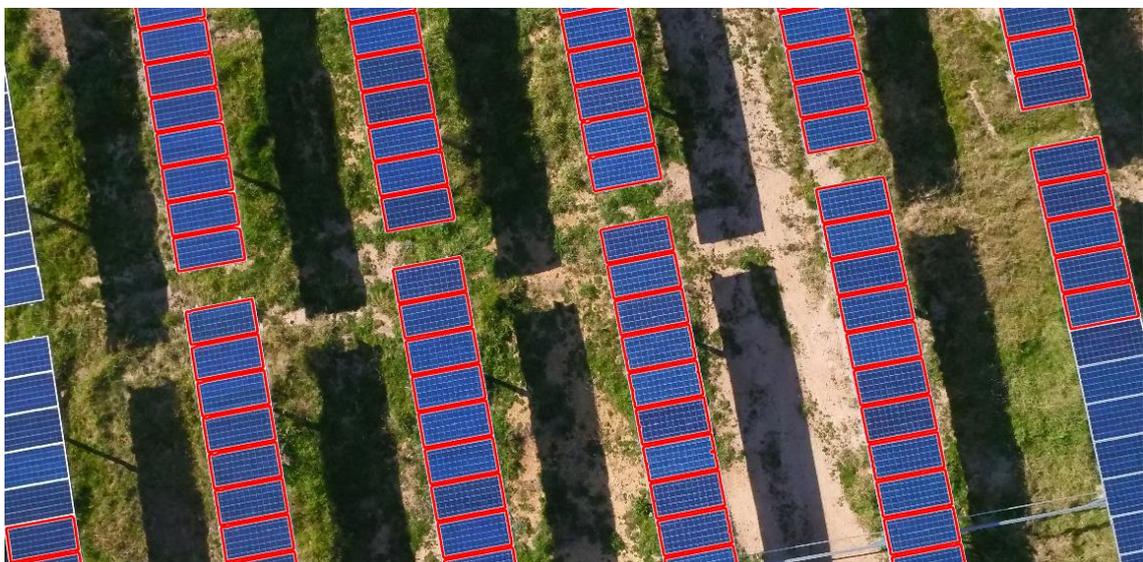
Figure 8. Image of photovoltaic panels at One Sun Solar's 12.2 MWe photovoltaic solar farm at Williamsdale NSW taken during data collection. Individual panels are identified and segmented as indicated with overlaid red rectangle demonstrating the first stage of the image processing pipeline.
