Lessons Learned Report

Santos oil beam pump conversion to solar and battery,
and other uses for the proposed stand-alone power
system

March 2020

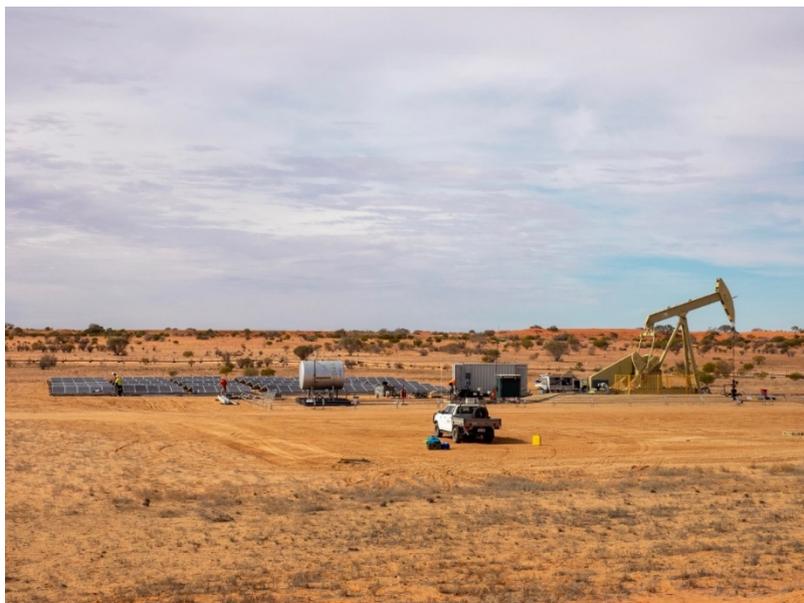
Photo 1: Stimpee-1 installation Cooper Basin

All selected sites for the solar and battery installation were outside of potential flood zones though battery containers have been elevated as a precautionary measure. Please refer Photo 1 below as an example layout.

All installations were constrained to the existing pre-disturbed lease area with some sites requiring limited civil works to level sites. This led to solar panels being orientated to the lease orientation rather than the most optimum solar orientation. As such, it is estimated solar performance has suffered an approximate 3-4% efficiency loss.
